Δυναμική Ευστάθεια
Αρθρωτών Κατασκευών

Νίκος Μακρής, Καθηγητής
email: nmakris@upatras.gr

Τομέας Κατασκευών, Πανεπιστήμιο Πατρών

The Reconstruction of the North-East Corner of the
Temple of Zeus at Nemea

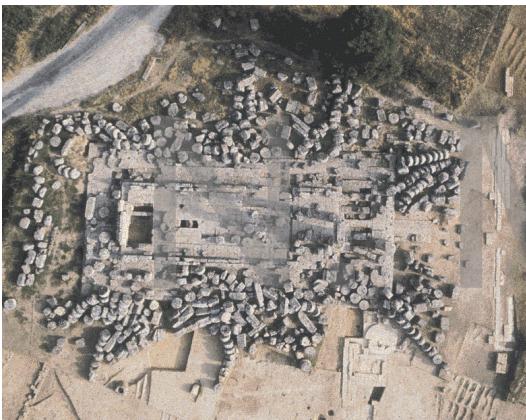
The challenge of reconstruction. Why reconstructing ?
Aerial View of the Temple (1977)

Columns have fallen to the outside

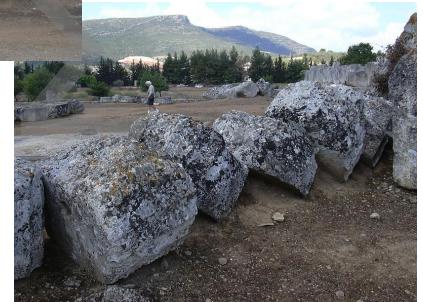
Eroded column drums

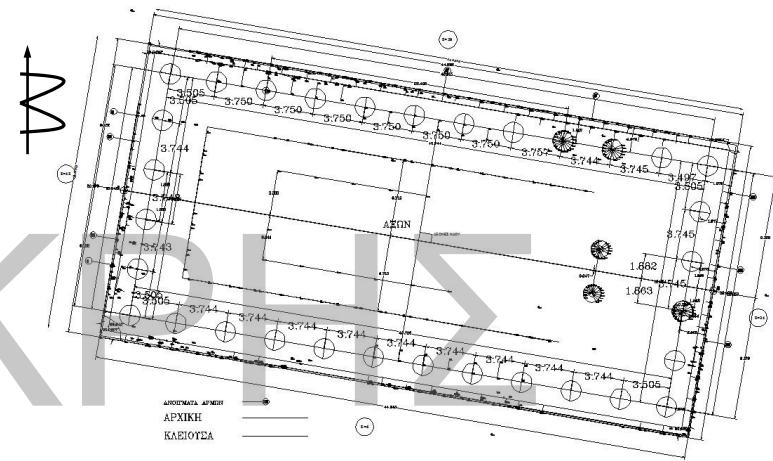
Detailed surveying of the current situation of the monument

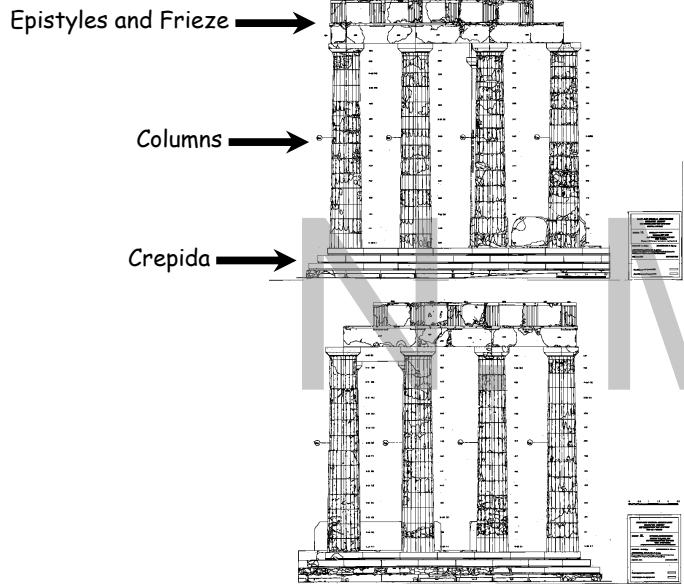
Establishment of the centers of the columns based on a sophisticated optimization analysis

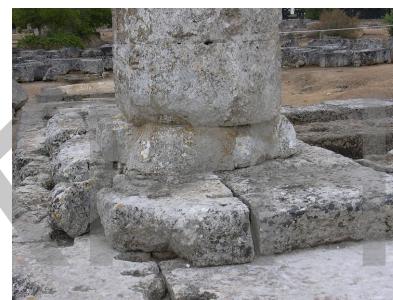
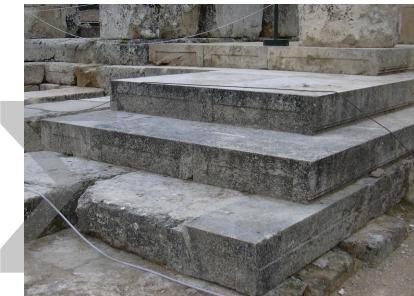
Reconstruction of the crepida

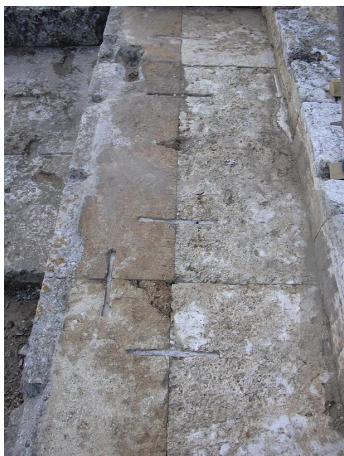
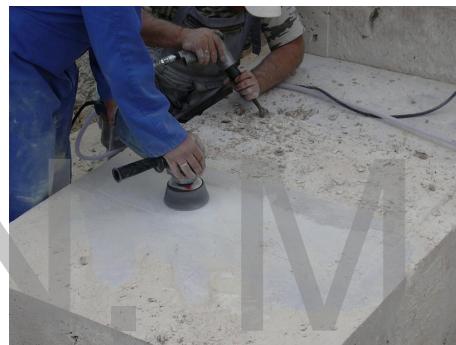
View of retrofitted ancient stones

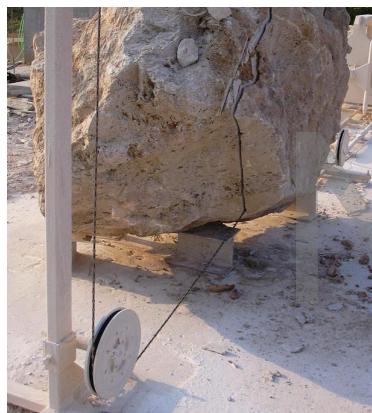
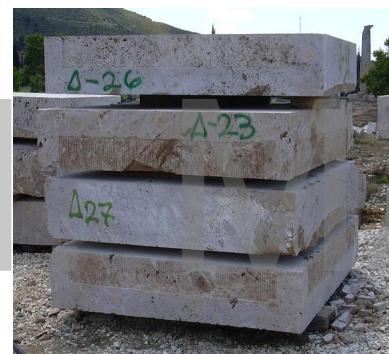
Wire-sawing and preparation of new material

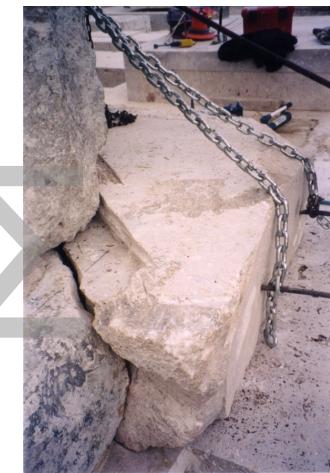
Retrofit of Δ-25: stylobate of ancient column K-31

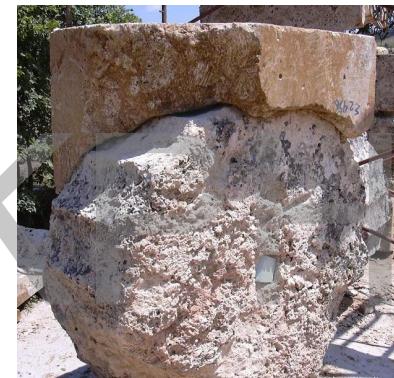
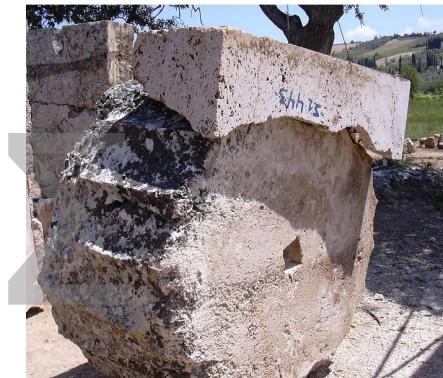
Need for retrofitting the column drums

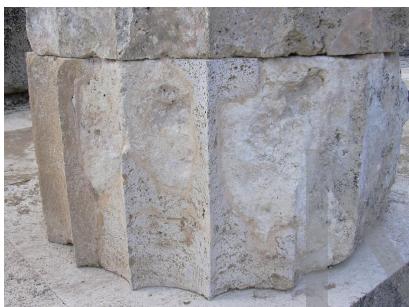
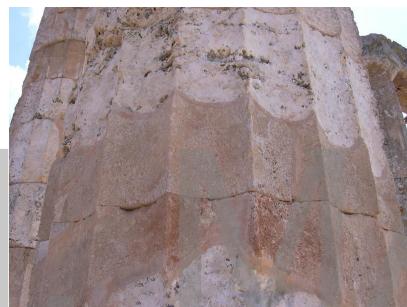
View of final result of retrofitted drums

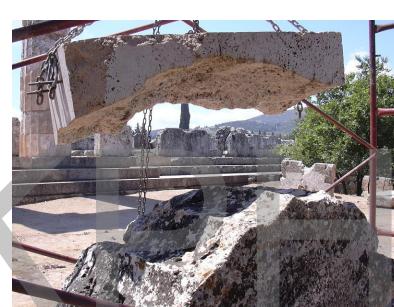
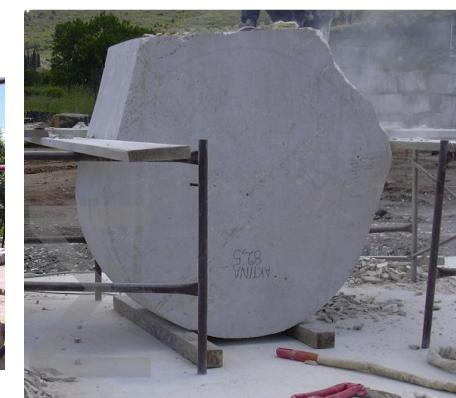
Works on existing and new column drums

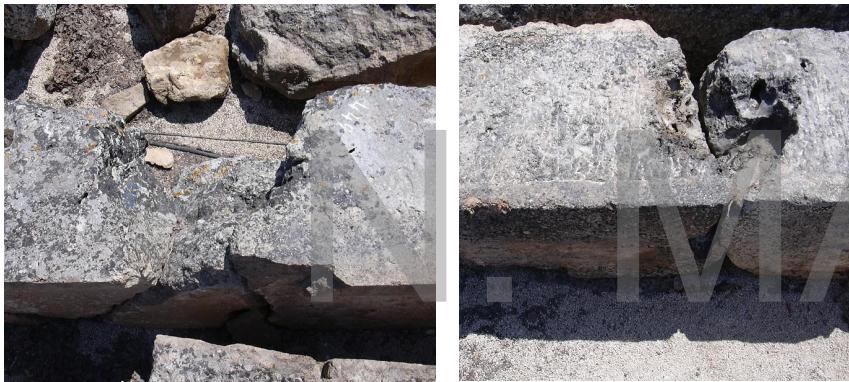
View of fragmented epistyles

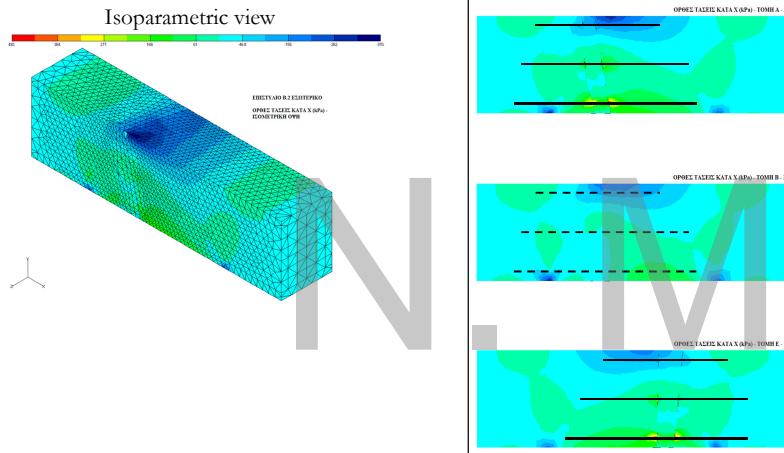
Normal stresses in the epistyle

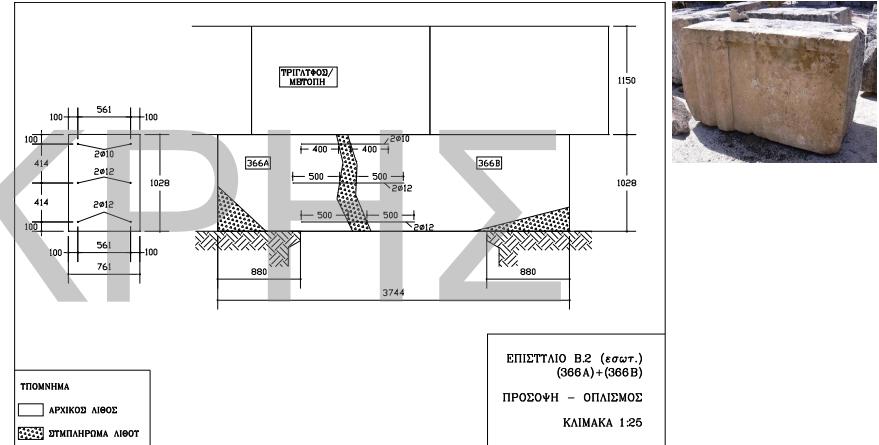
Schematic of retrofitted epistyle

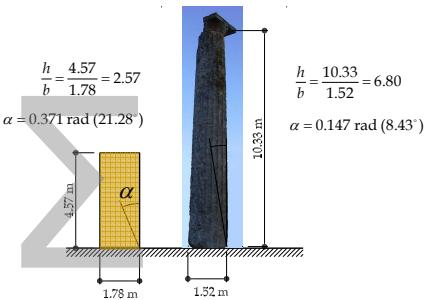
Seismic Stability of free-standing slender structures

$$\frac{h}{b} = \frac{4.57}{1.78} = 2.57$$

$$\alpha = 0.371 \text{ rad (21.28°)}$$

500 kV Electrical Transformer

Column K-31

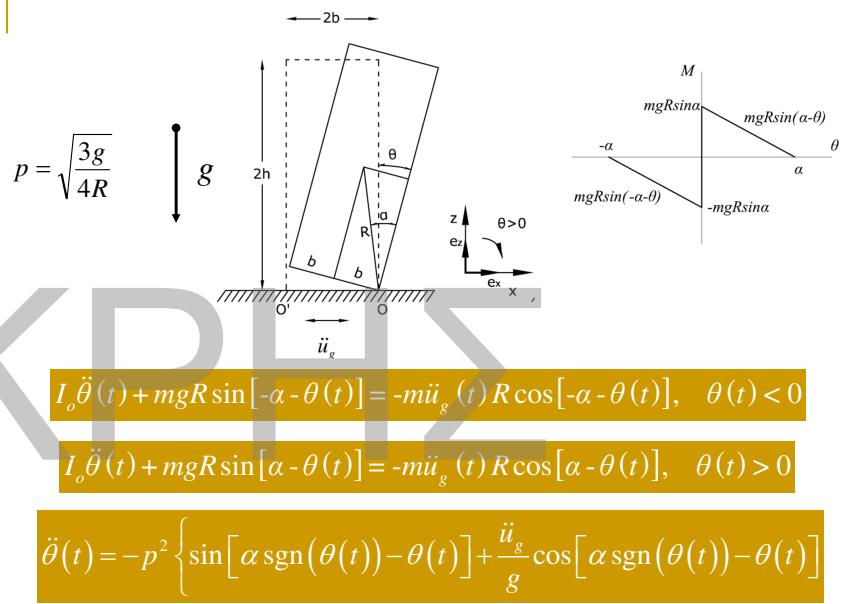
$$I_o \ddot{\theta}(t) + mgR \sin[-\alpha - \theta(t)] = -m\ddot{u}_g(t) R \cos[-\alpha - \theta(t)], \quad \theta(t) < 0$$

$$I_o \ddot{\theta}(t) + mgR \sin[\alpha - \theta(t)] = -m\ddot{u}_g(t) R \cos[\alpha - \theta(t)], \quad \theta(t) > 0$$

$$\ddot{\theta}(t) = -p^2 \left\{ \sin[\alpha \operatorname{sgn}(\theta(t)) - \theta(t)] + \frac{\ddot{u}_g}{g} \cos[\alpha \operatorname{sgn}(\theta(t)) - \theta(t)] \right\}$$

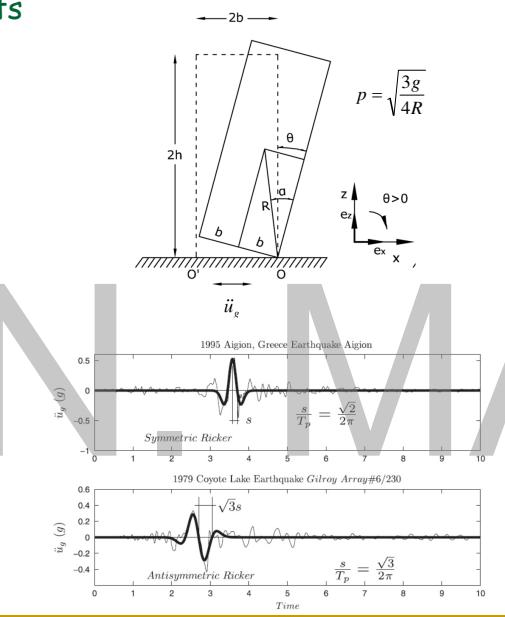
Dimensionless Products

$$\theta(t) = \varphi\left(\frac{\omega_p}{p}, \tan \alpha, \frac{a_p}{g}\right)$$

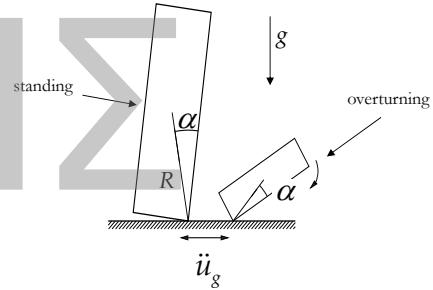
Fundamental size-frequency effect: 1963 George W. Housner

(a) The larger of two geometrically similar blocks can survive the excitation that will topple the smaller block; and (b) out of two same acceleration-amplitude pulses the one with the longer duration is more capable to induce overturning

Conclusion reached from studies motivated from the destruction observed after the May 1960 earthquake in Chile.

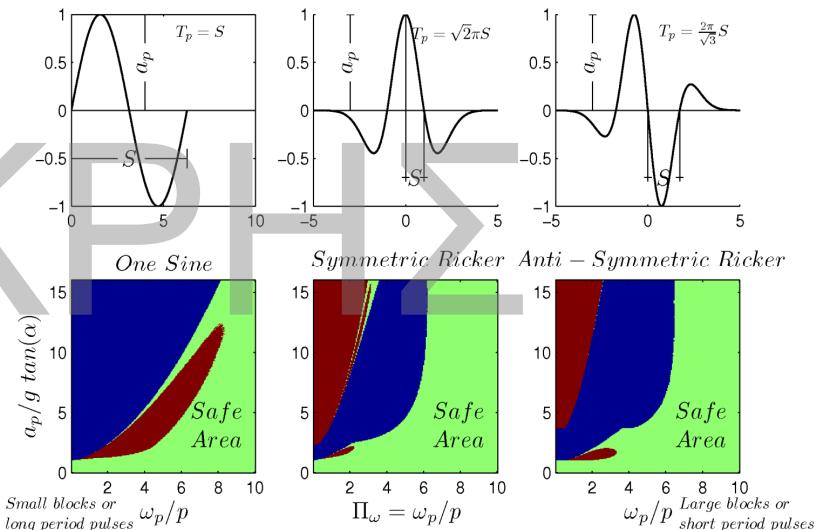
Overturning spectra of a rigid block standing free on a monolithic base

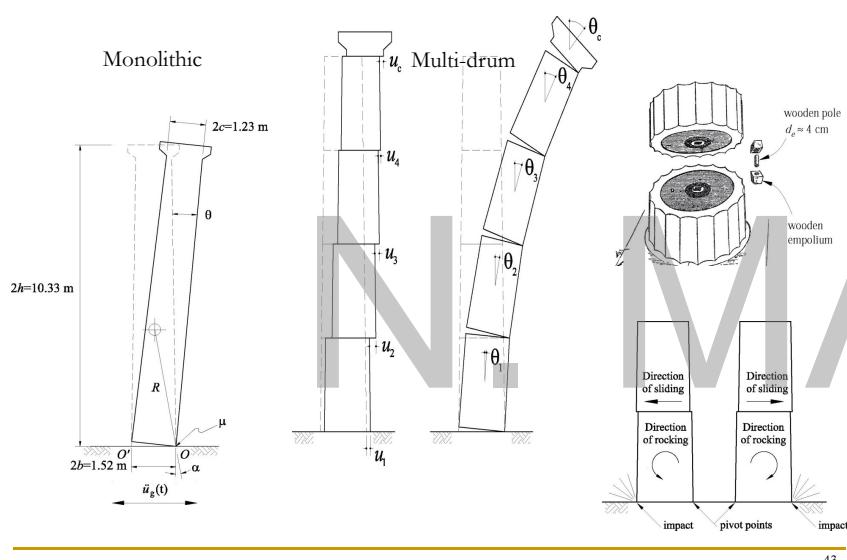
Seismic response of monolithic and multi-drum column

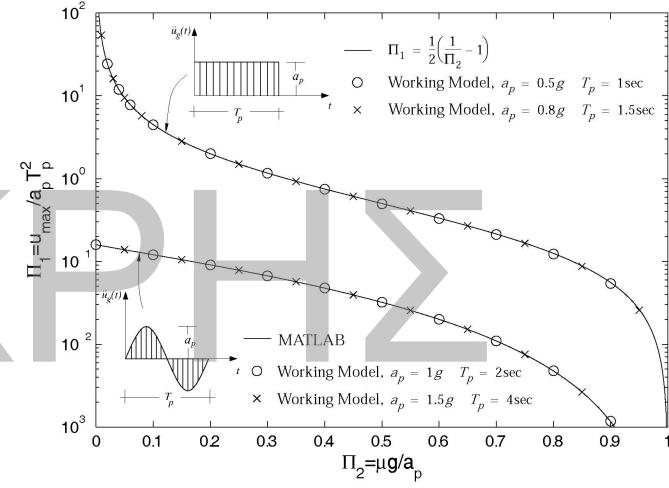
Peak Displacement of a Sliding Block Subjected to Square and One-Sine Pulse Excitations

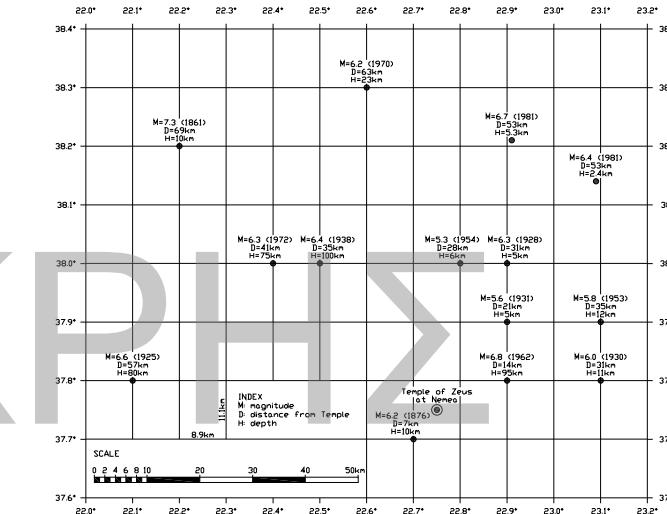
Seismic Hazard

Location of selected historic earthquakes nearby the Temple of Zeus at Nemea.

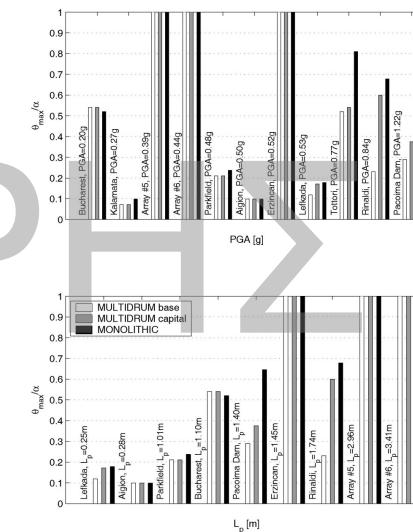
Peak column rotations from various historic strong earthquake motions
